Re: Monthly Report Summary #13 for the South Orange County Reliability Enhancement (SOCRE) Project

CPUC Site Inspection Reports
November 2, 7, 15, and 27, 2018

South Orange County Reliability Enhancement Project CPUC Site Inspection Form

Project:	South Orange County Reliability Enhancement (SOCRE) Project	Date:	November 2, 2018
Project Proponent:	San Diego Gas & Electric (SDG&E)	Report #:	VS013
Lead Agency:	California Public Utilities Commission (CPUC)	Monitor(s):	CPUC/Ecology and Environment (E & E) Compliance Monitor
CPUC PM:	Andrew Barnsdale, Energy Division	AM/PM Weather:	Sunny, cool, and calm
CPUC CM (E & E):	Joe Donaldson	Start/End Time:	0700 to 0845
Project NTP(s):	NTP-1, NTP-2, NTP-2 Addendum 1, and NTP-3

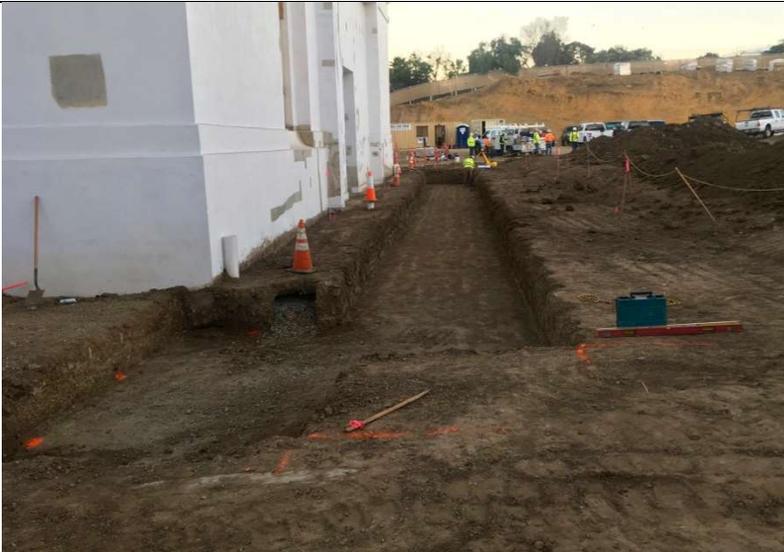
Some excavation work had been conducted east of the former utility structure (Photo 1). The SDG&E Lead Environmental Inspector indicated the excavation was for the storm drain system. Moisture barrier work continued on the southern boundary wall, which included painting the brick with a thick black sealant (Photo 2).

Photo 1 – Trench work near the former utility structure. Photo facing north.
11/02/18	San Juan Capistrano Substation

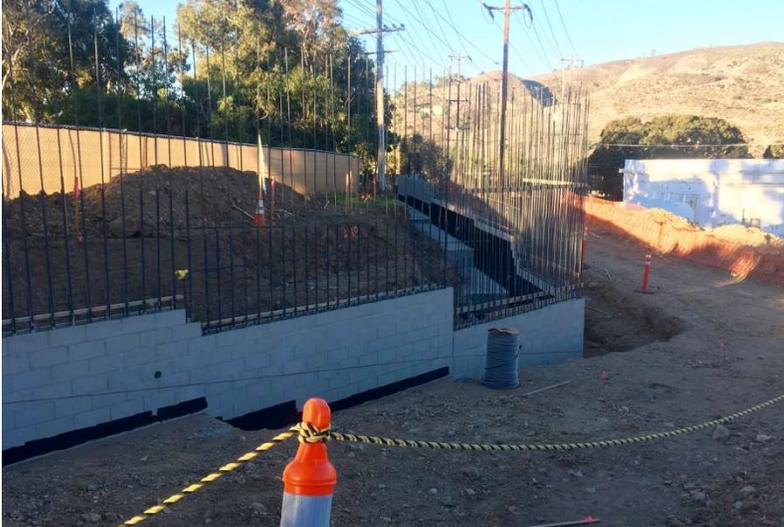
Photo 2 – Work on the southern boundary wall. Photo facing west.

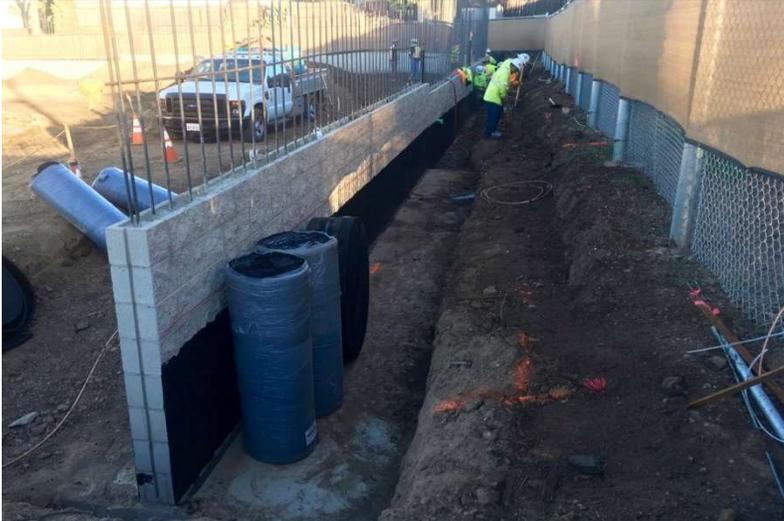
On the northern boundary wall, a moisture barrier was being installed on the exterior side of the wall (Photos 3 and 7). On the interior side of the northern boundary wall, the moisture barrier had been completed and backfilled (Photo 4). The mortar mixing station remained onsite for future brick laying work (Photo 5). All of the equipment was sealed up and contained, to the extent necessary.

Photo 3 – Sealing the northern boundary wall. Photo facing north.
11/02/18	San Juan Capistrano Substation

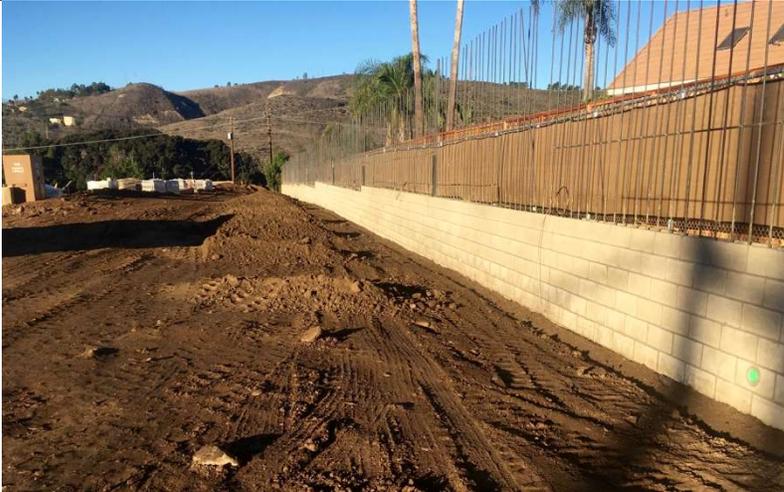
Photo 4 – Backfilling has been completed along the inside of the northern boundary wall. Photo facing west.
11/02/18	San Juan Capistrano Substation

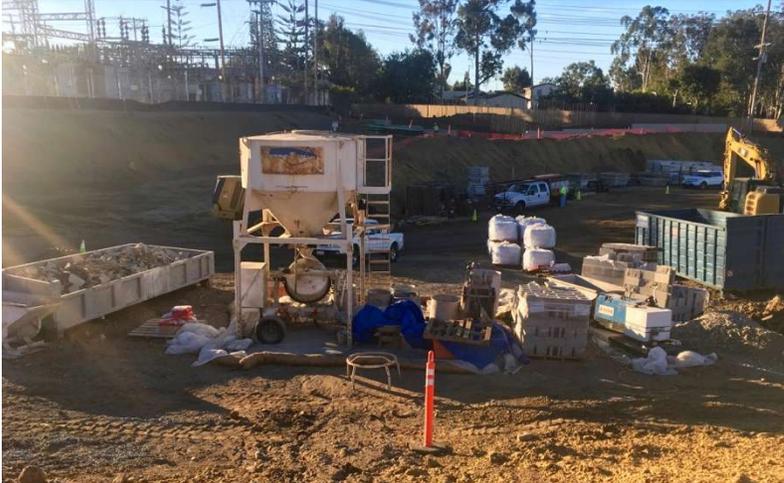
Photo 5 – Overview of the mortar mixing station. Photo facing south.

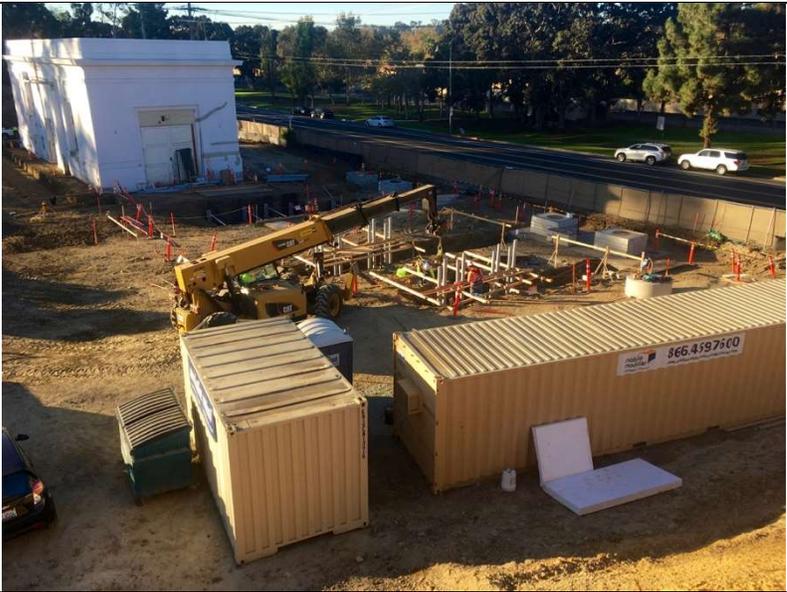
Conduit installation was ongoing in the two trenches associated with the two large vault boxes (Photo 6). The northern trench had conduit in place and was ready for pouring (Photo 8). The southern conduit trench was shored up and ready for the installation work (Photo 9).

Photo 6 – Installation of conduit vaults and pipe. Photo facing southwest.
11/02/18	San Juan Capistrano Substation

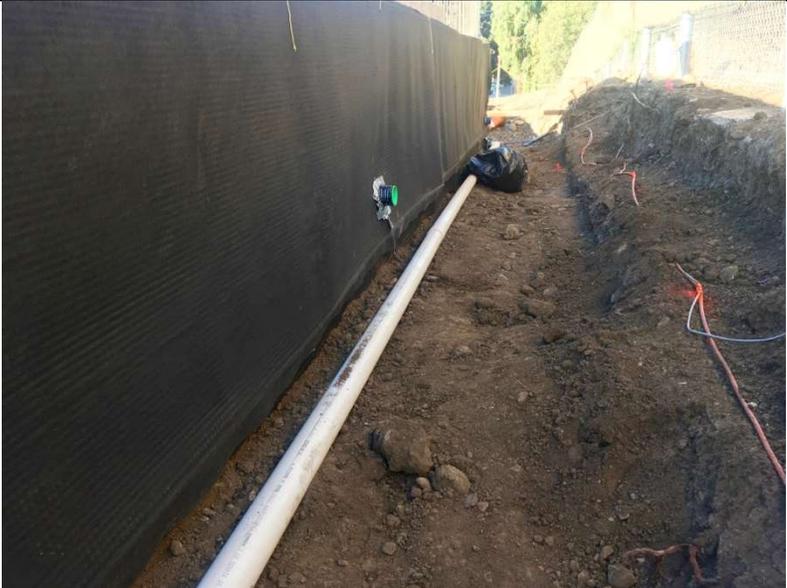
Photo 7 – Moisture barrier application along the outside of the northern boundary wall. Photo facing west.

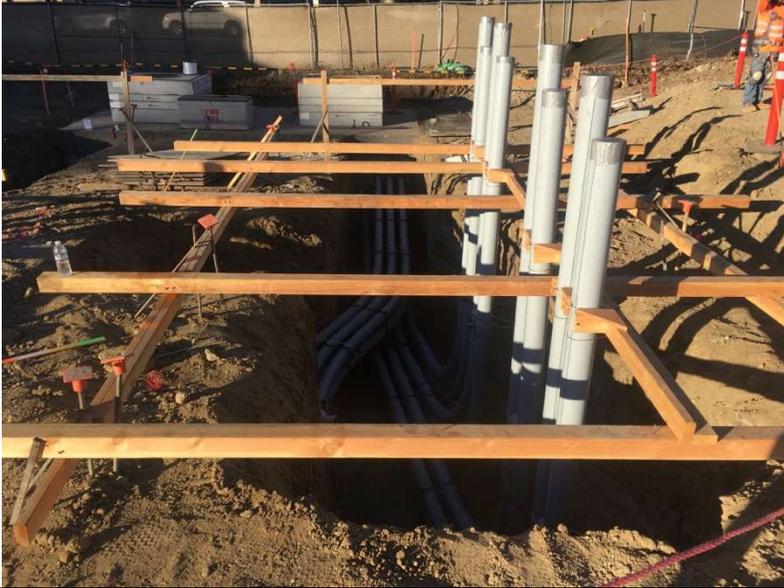
Photo 8 – Conduit installation. Photo facing west.
11/02/18	San Juan Capistrano Substation

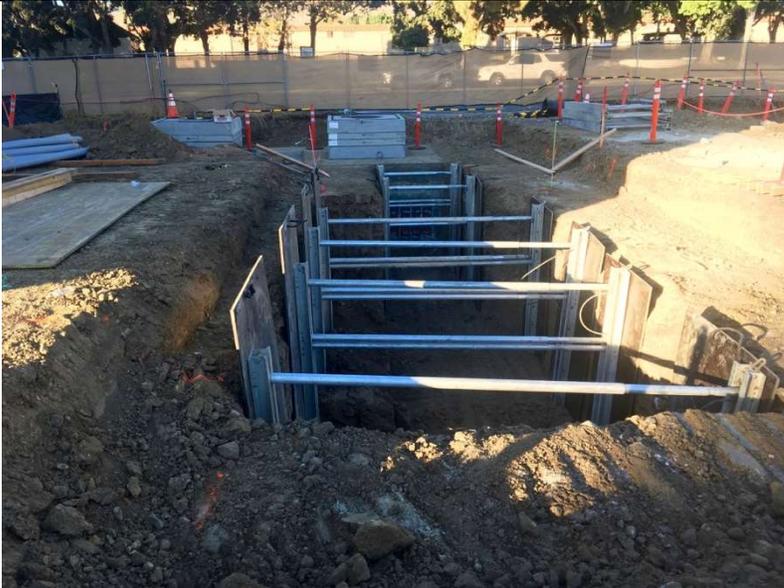
Photo 9 – Conduit vault with shoring. Photo facing west.

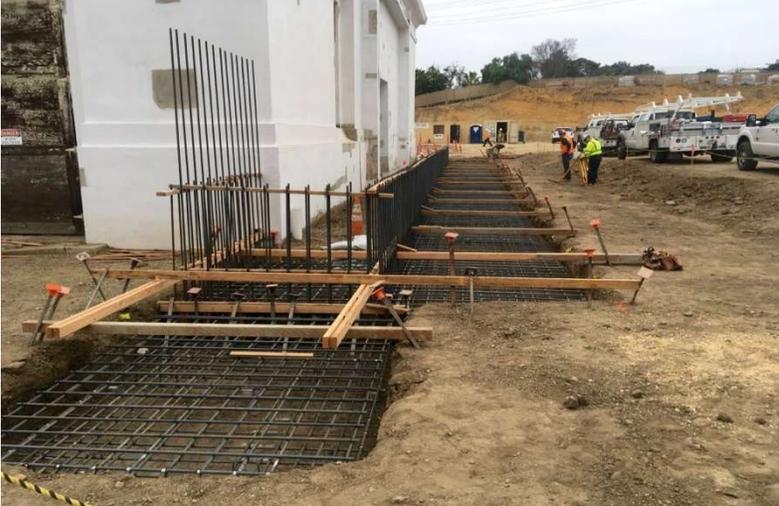
Work continued on the foundation to the east of the former utility structure, including rebar installation (Photo 1). Concrete was scheduled to be poured in this area during the following one to two days; a concrete washout station was onsite.

Photo 1 – Rebar installation in the trench near the former utility structure. Photo facing north.
11/07/18	San Juan Capistrano Substation

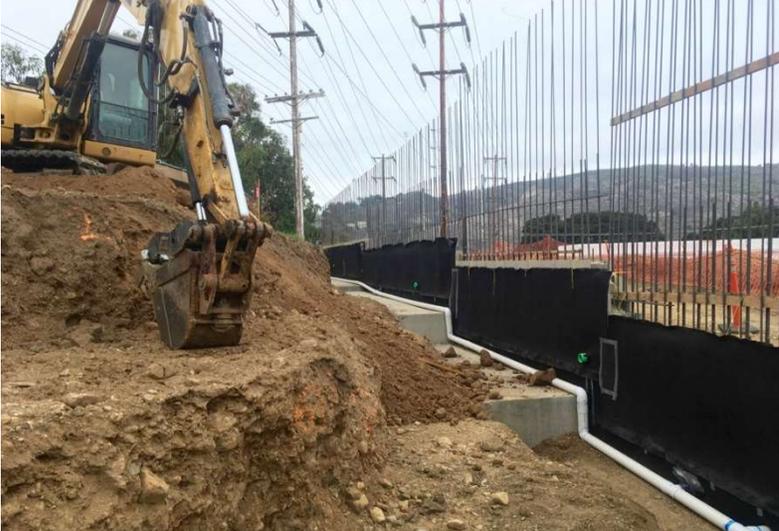
Moisture barrier work continued on the southern boundary wall, including installation of a moisture barrier and drainage piping (Photo 2). The same work was also being conducted on the northern boundary wall (Photo 3). A windrow of excess soil was stockpiled along the inside of the northern boundary wall (Photo 4). I spoke with the SDG&E Environmental Coordinator about the need for dust control at this location.

Photo 2 – Work on the southern boundary wall. Photo facing west.

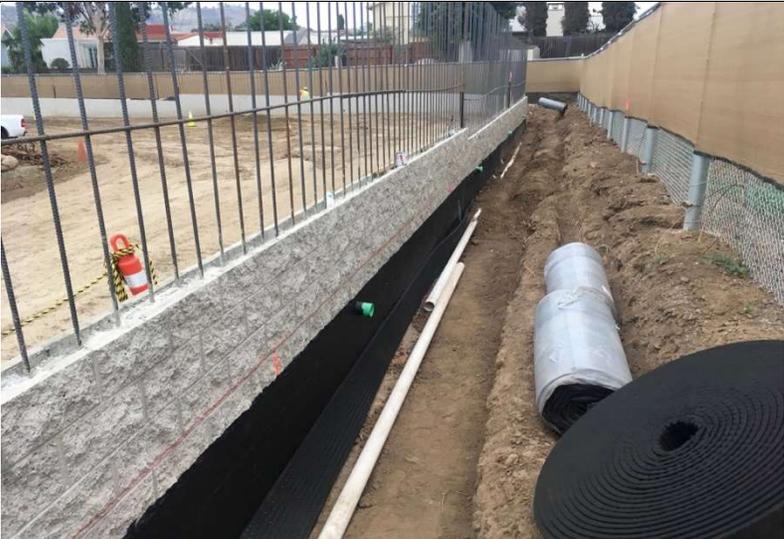
Photo 3 – Sealing the outside of the northern boundary wall. Photo facing north.
11/07/18	San Juan Capistrano Substation

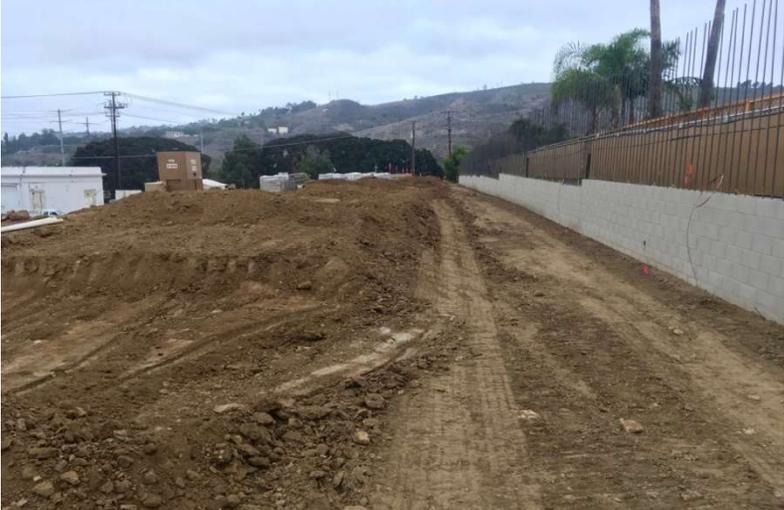
Photo 4 – Excess soil along the northern boundary wall. Photo facing west.
11/07/18	San Juan Capistrano Substation

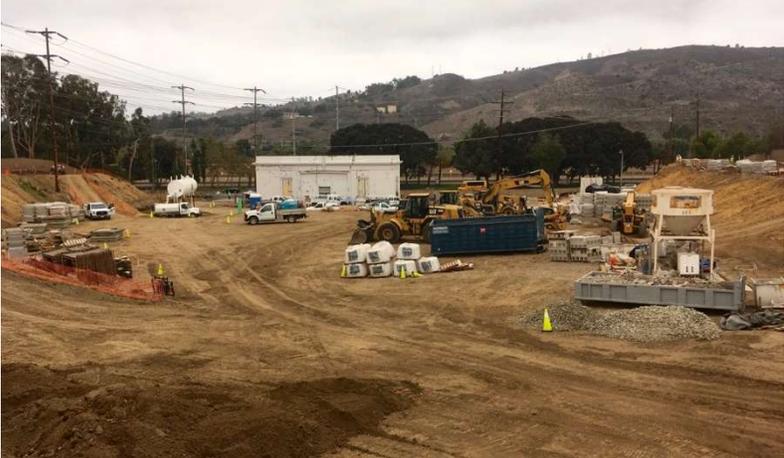
Photo 5 – Overview of the western half of the San Juan Capistrano Substation site. Photo facing west.

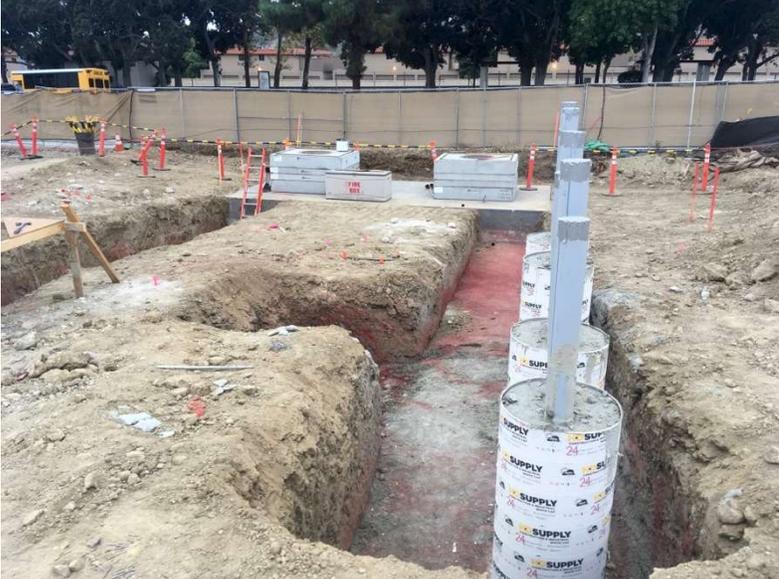
Photo 6 – Conduit vaults and pipe installation. Photo facing west.
11/07/18	San Juan Capistrano Substation

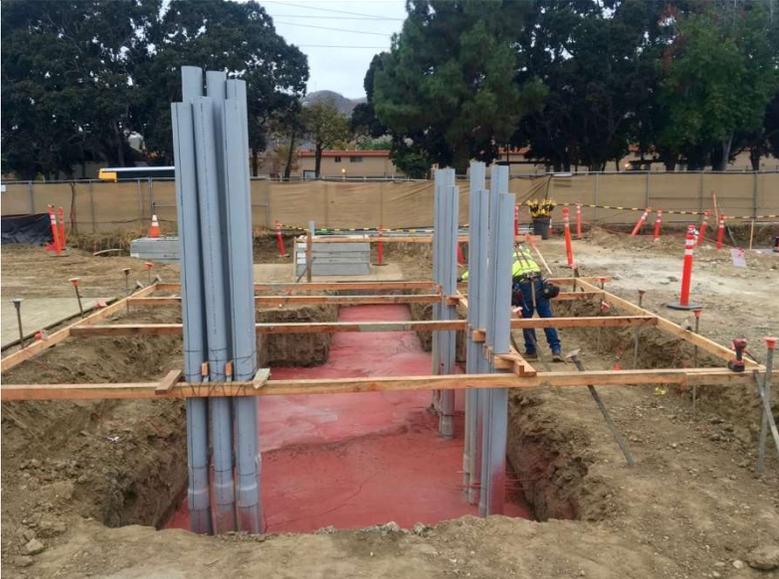
Photo 7 – Slurry poured in the conduit trench. Photo facing west.
11/07/18	San Juan Capistrano Substation

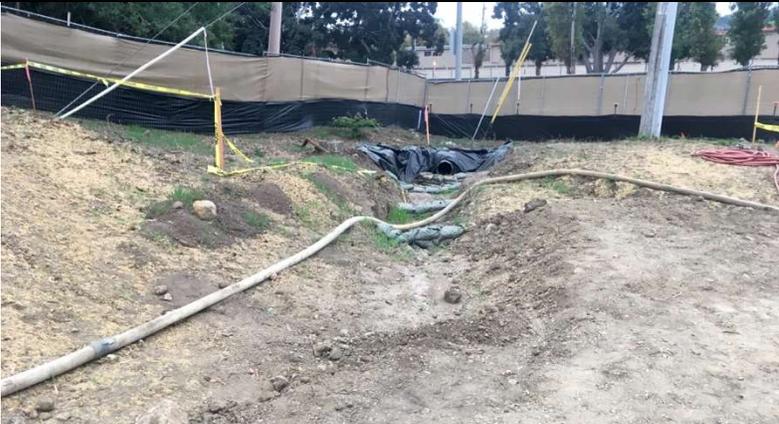
Photo 8 – Storm water catch basin. Photo facing southwest.

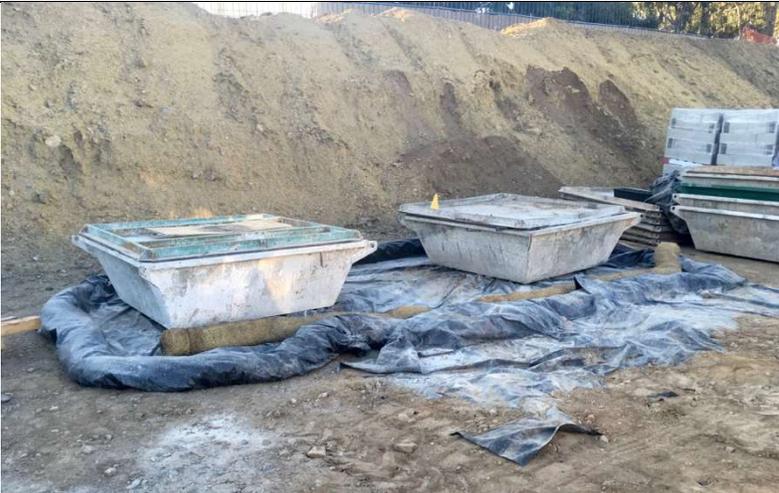
Several concrete washout bins were onsite. The two in use were covered and well contained (Photo 1). A large drainpipe was being installed east of the former utility structure (Photo 2). In addition to the drainpipe installation, a variety of excavation activities were being conducted within the San Juan Capistrano Substation site, including some trenching (Photo 4) and drilling for a tower foundation (Photo 5) in the Capistrano Substation area, and earthwork in the northwestern portion of the San Juan Capistrano Substation site (Photo 8). Based on the activities being conducted, a paleontological resources monitor, archaeological resources monitor, and cultural resources monitor were scheduled to be onsite. To date, nothing of significance had been discovered by the monitors; however, a number of old bottles have been exposed during excavation activities.

Photo 1 – Concrete washout basins, covered and contained.
11/15/18	San Juan Capistrano Substation

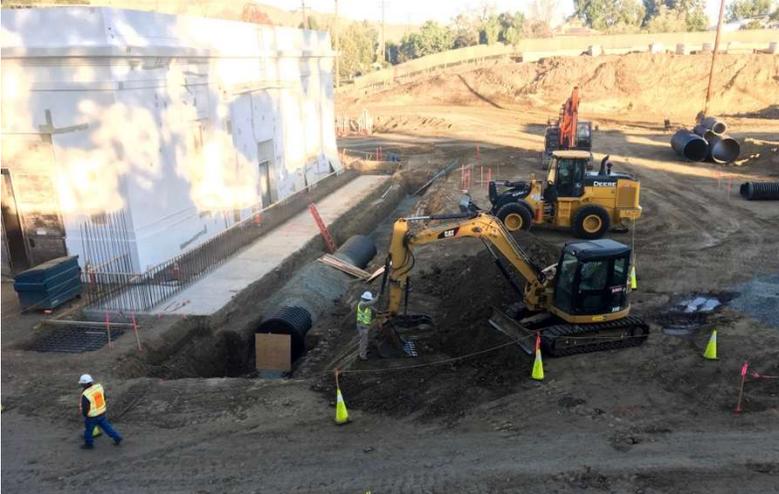
Photo 2 – Storm drain system being installed. Photo facing north.
11/15/18	San Juan Capistrano Substation

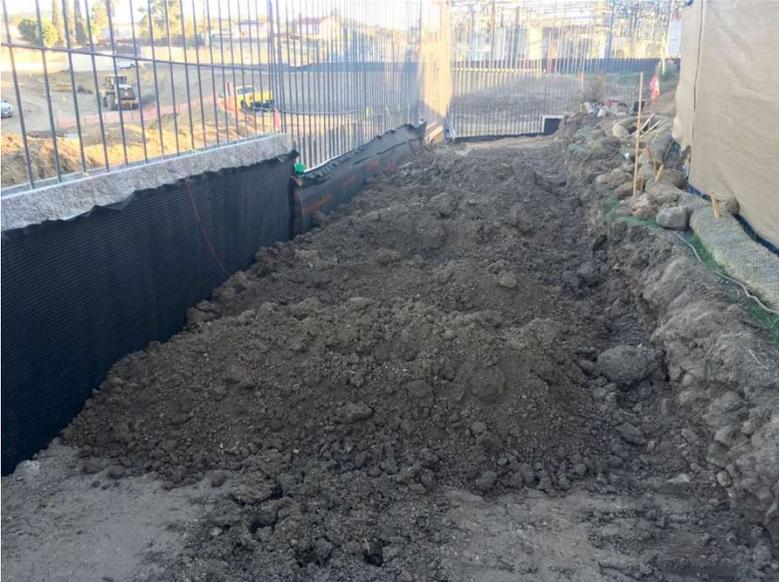
Photo 3 – Backfilling behind the southern boundary wall. Photo facing east.

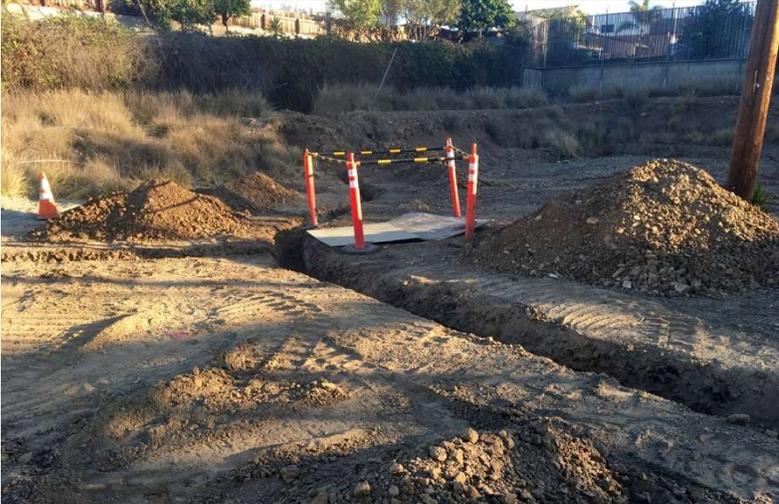
Photo 4 – Trenching within the Capistrano Substation. Photo facing east.
11/15/18	San Juan Capistrano Substation

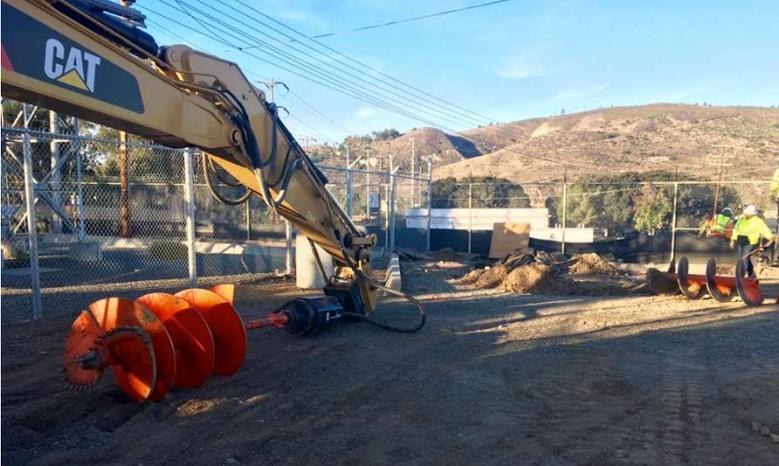
Photo 5 – Foundation drilling within the Capistrano Substation. Photo facing west.
11/15/18	San Juan Capistrano Substation

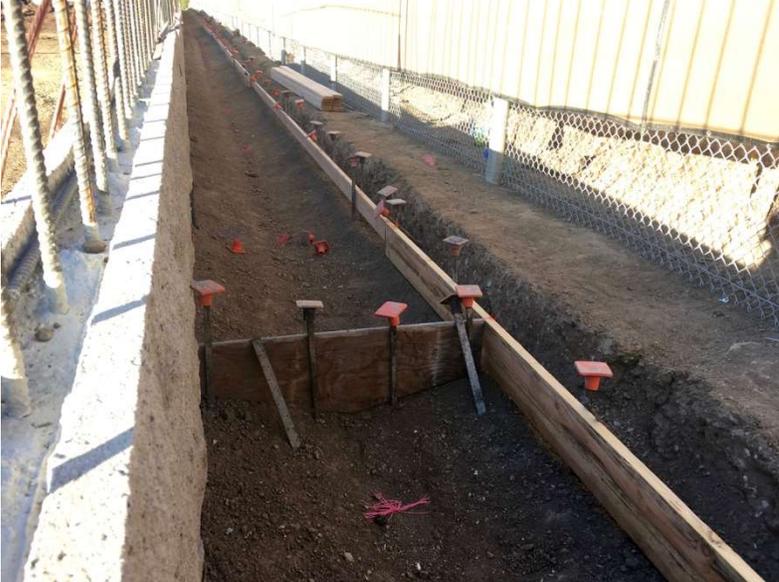
Photo 6 – “V” ditch being formed outside of the northern boundary wall. Photo facing west.

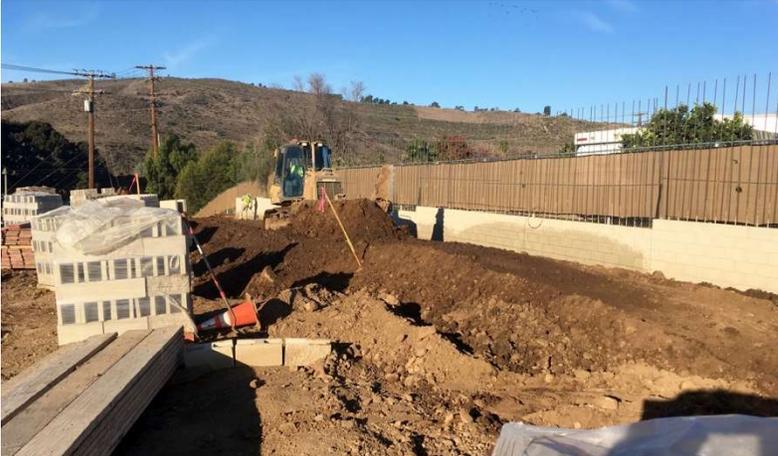
Photo 7 – Earthwork along the northern boundary wall. Photo facing west.
11/15/18	San Juan Capistrano Substation

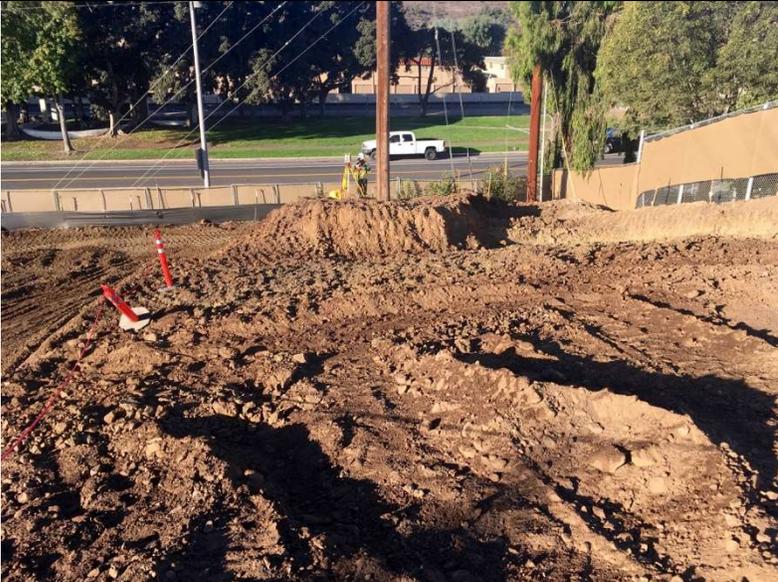
Photo 8 – Earthwork being conducted in the northwest corner of the San Juan Capistrano Substation site. Photo facing west.
11/15/18	San Juan Capistrano Substation

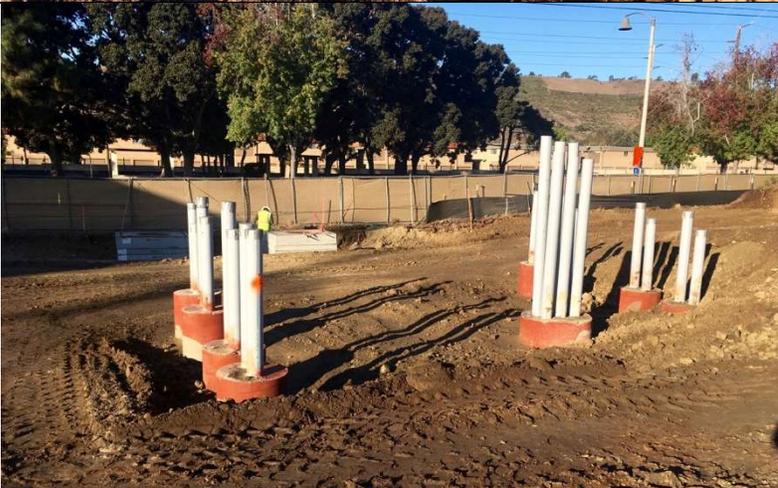
Photo 9 – Conduit poured and backfilled. Photo facing west.

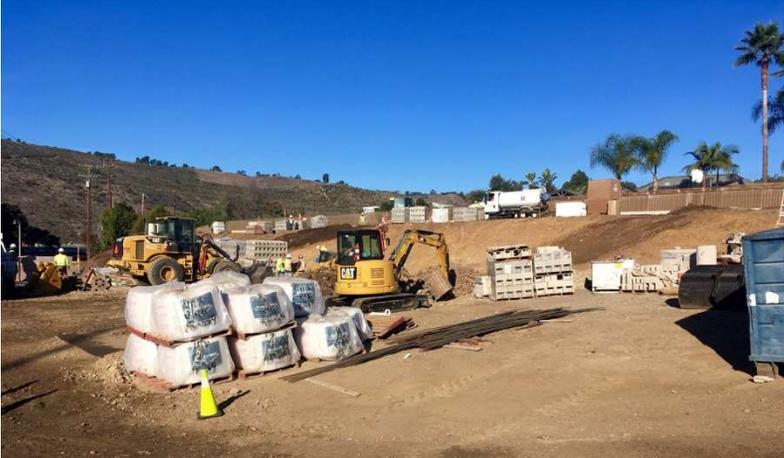
Photo 10 – Overview of the northwest portion of the San Juan Capistrano Substation site. Photo facing northwest.

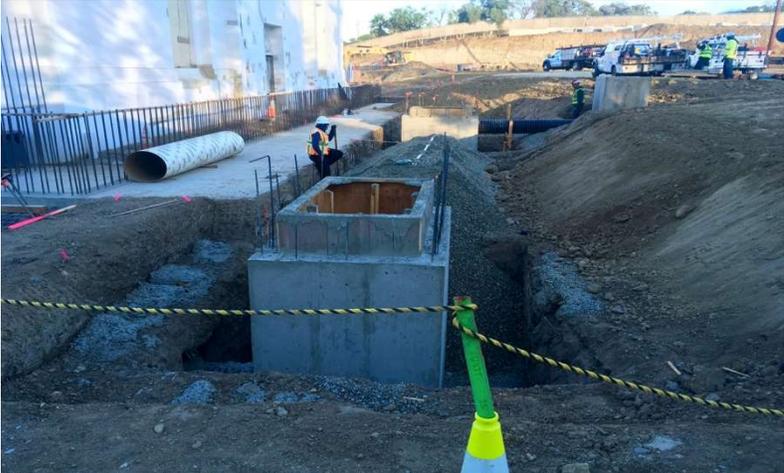
Photo 1 – Backfilling the storm drain piping near the former utility structure. Photo facing north.
11/27/18	San Juan Capistrano Substation

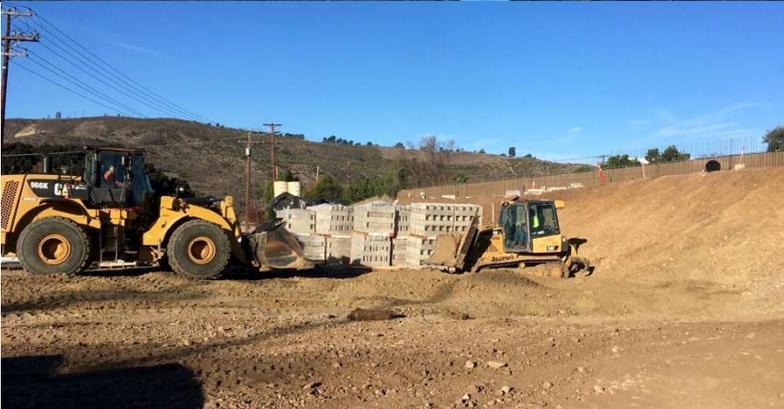
Photo 2 – Equipment moving soil. Photo facing northwest.
11/27/18	San Juan Capistrano Substation

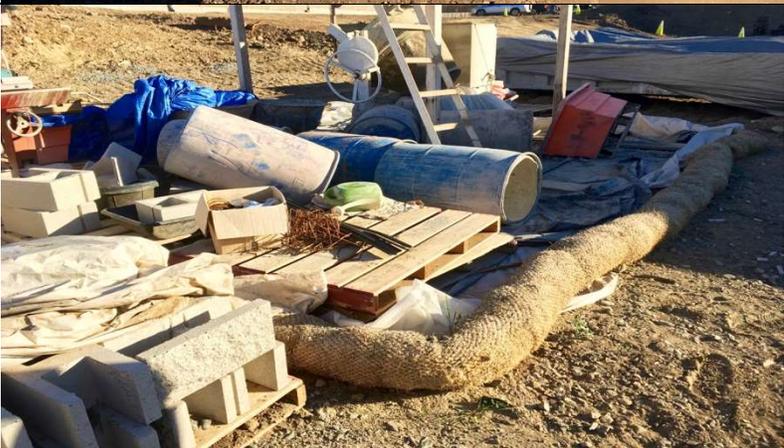
Photo 3 – Mortar mixing station.

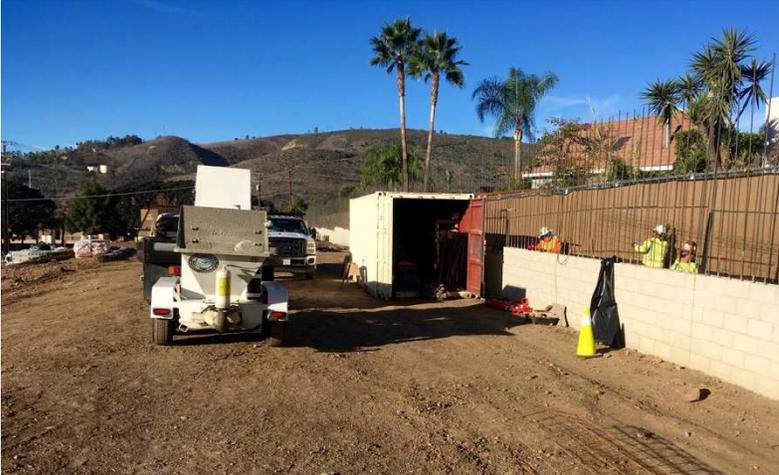
Photo 4 – Pouring the “brow ditch” along the northern boundary wall. Photo facing west.
11/27/18	San Juan Capistrano Substation

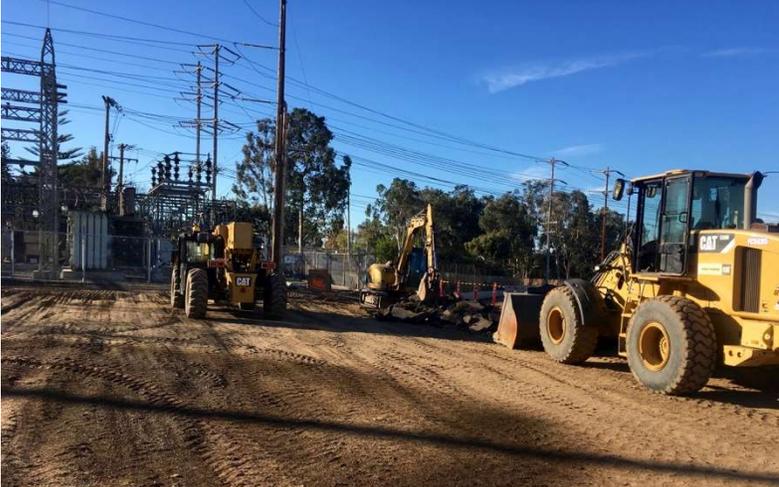
Photo 5 – Equipment parked in the Capistrano Substation area. Photo facing south.
11/27/18	San Juan Capistrano Substation

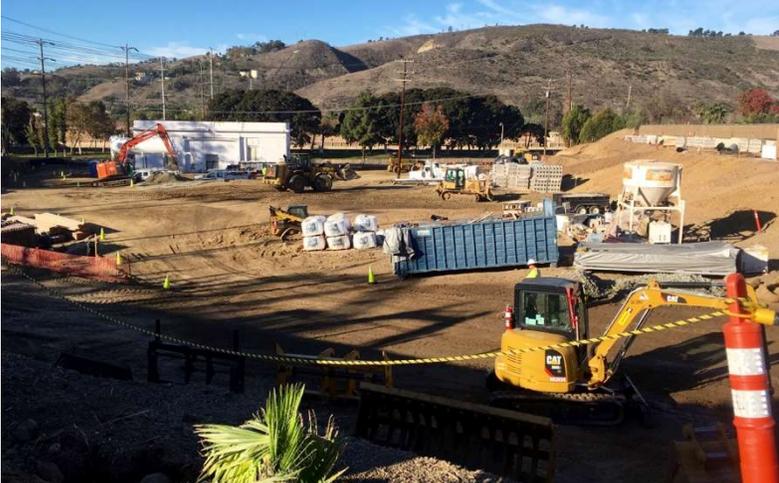
Photo 6 – San Juan Capistrano Substation site overview. Photo facing west.

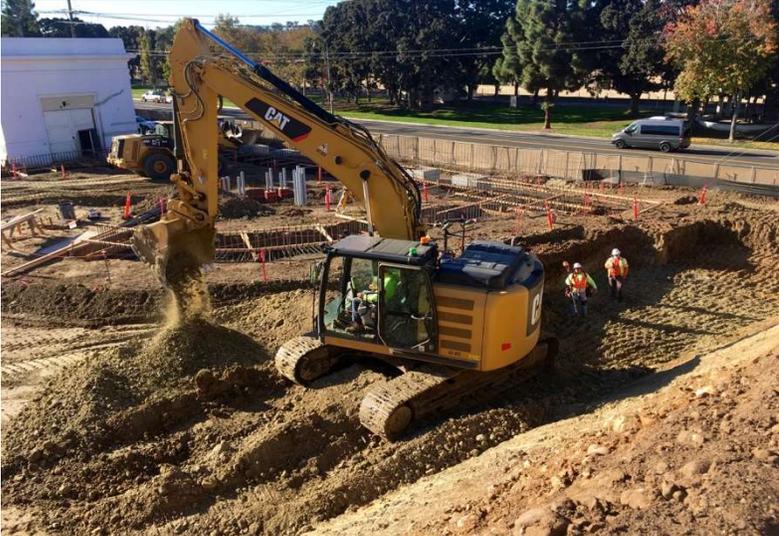
Photo 7 – Excavator moving dirt near the southwestern corner of the San Juan Capistrano Substation site. Photo facing southwest.
11/27/18	San Juan Capistrano Substation

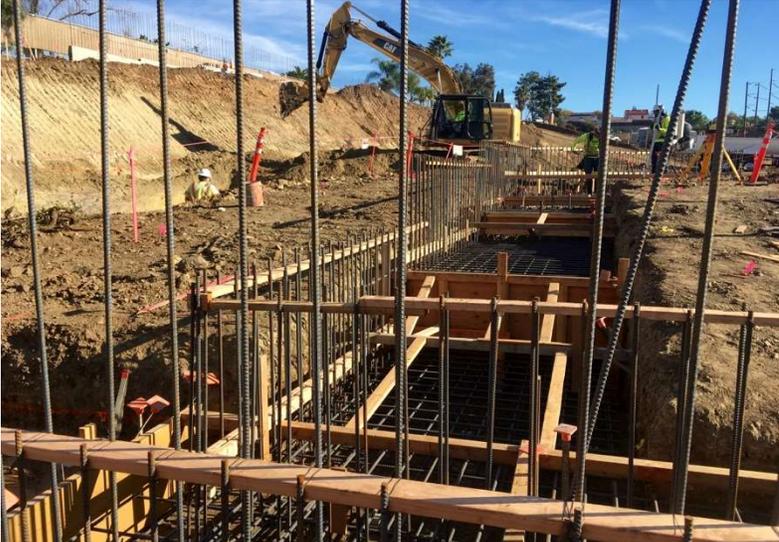
Foundation and wall work continued along the southern end of the San Juan Capistrano Substation site (Photos 8 and 9).

Photo 8 – Foundation work along the southern boundary. Photo facing east.
11/27/18	San Juan Capistrano Substation

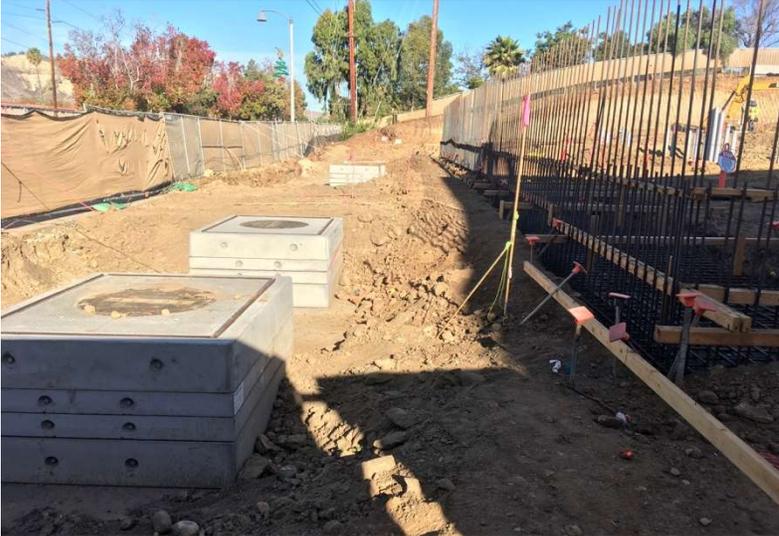
Photo 9 – Foundation work along the southern boundary. Photo facing north.

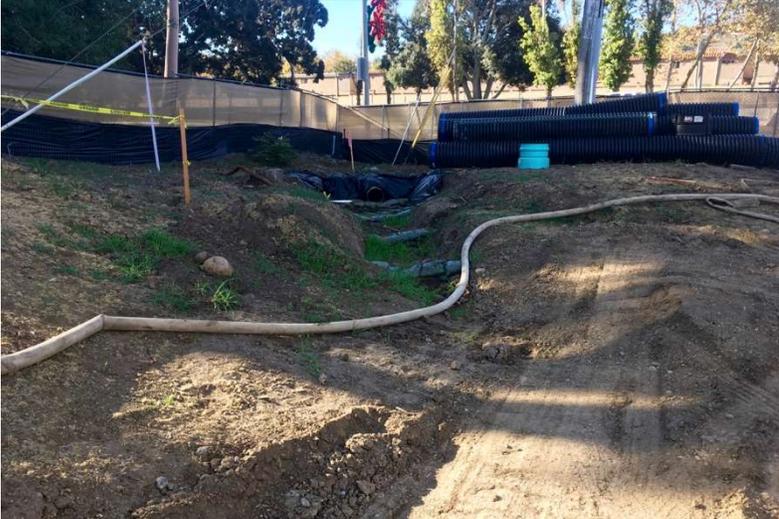
<p>Photo 10 – Rainwater catch basin in the southwestern corner of the San Juan Capistrano Substation site. Photo facing southwest.</p>
11/28/18	San Juan Capistrano Substation

A larger catch basin in the southwestern corner of the San Juan Capistrano Substation site is recommended.

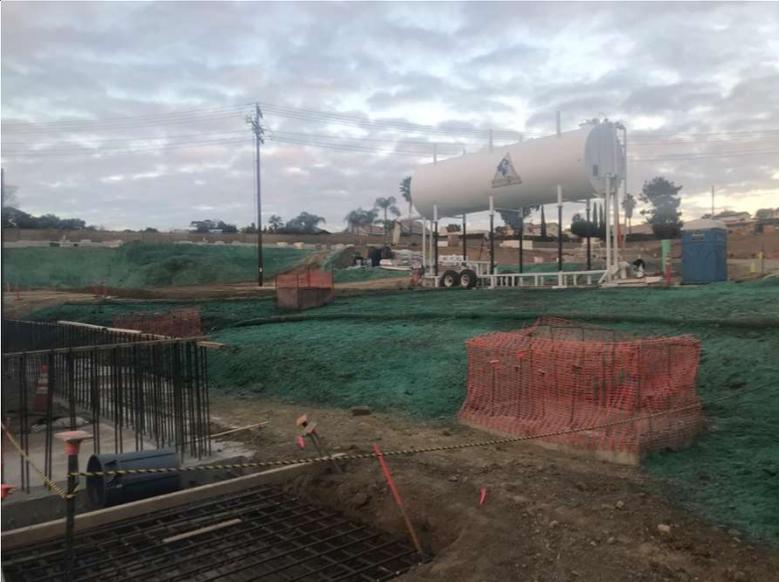
<p>Photo 11 – Taken by the SDG&E Lead Environmental Inspector; site preparations, including hydromulching. Photo facing northeast.</p>
11/28/18	San Juan Capistrano Substation

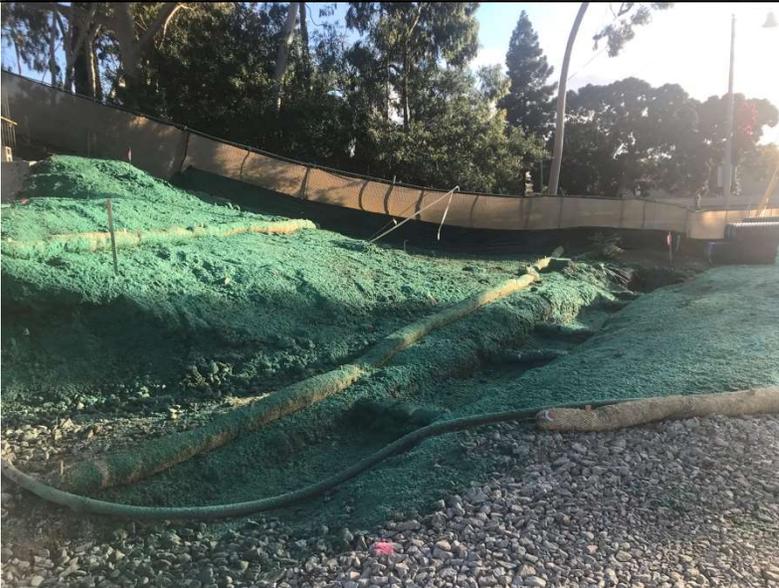
<p>Photo 12 - Taken by the SDG&E Lead Environmental Inspector; site preparations, including hydromulching. Photo facing southwest.</p>
